# **Attachment K**

**Inspection Report  
398-402 Sussex Street, Haymarket**

## **Council Investigation Officer Inspection and Recommendation Report; Clause 17(2) Part 8 of Schedule 5 of the Environmental Planning and Assessment Act 1979 (the Act)**

**Re: INSPECTION REPORT  
'THE WORKHOUSE'  
398-402 SUSSEX STREET, HAYMARKET ("the premises")**

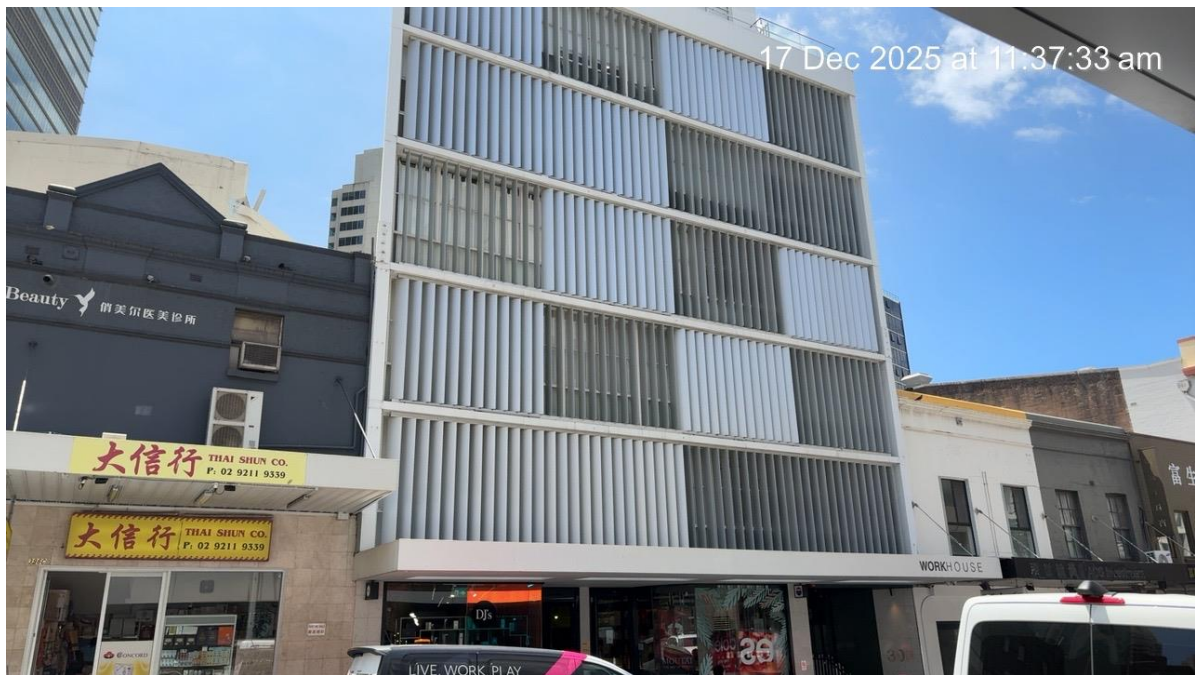
**Figure 1:** 398-402 Sussex Street, Haymarket, viewed from the south-west
