# **Attachment J**

**Inspection Report  
2-4 Cunningham Street, Haymarket**

# **Council Investigation Officer Inspection and Recommendation Report; Clause 17(2) Part 8 of Schedule 5 of the Environmental Planning and Assessment Act 1979 (the Act)**

**Premises:** 2-4 Cunningham Street, Haymarket

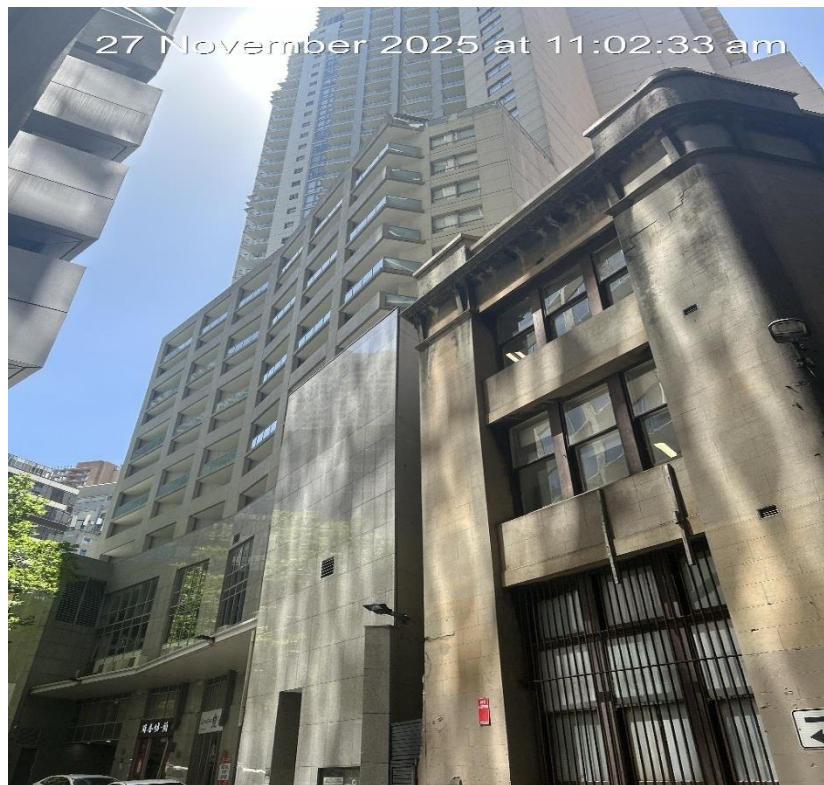
**Figure 1:** 2-4 Cunningham Steet, Haymarket, viewed from the east

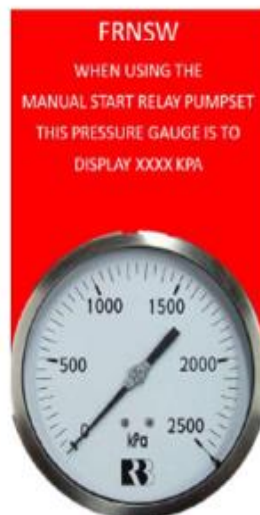
Figure 1

FRNSW position statement '[FRNSW pump performance for high rise buildings](#)' states, the fire hydrant system is to be designed for a 'Boost Pressure' of 950 kPa being input into the fire brigade booster connection from a standard FRNSW pumper, for buildings having an effective height greater than 50 m and requiring a fire brigade relay pump. FRNSW are of the opinion that the boost pressure signage should state, BOOST PRESSURE 950kPa and the relay pump be modified to ensure correct operational pressures.

Additional signage should be installed along with a 150mm pressure gauge similar to *Figure 1*, to advise firefighters of the required pressure at the RELAY PUMP discharge.
