# **Attachment C**

**Inspection Report  
187-189 Thomas Street, Haymarket**

**Council Investigation Officer Inspection and Recommendation Report; Clause 17(2) Part 8 of Schedule 5 of the Environmental Planning and Assessment Act 1979 (the Act)**

**Re: INSPECTION REPORT  
QUAY CONNECTION  
187-189 THOMAS STREET HAYMARKET ("the premises")**

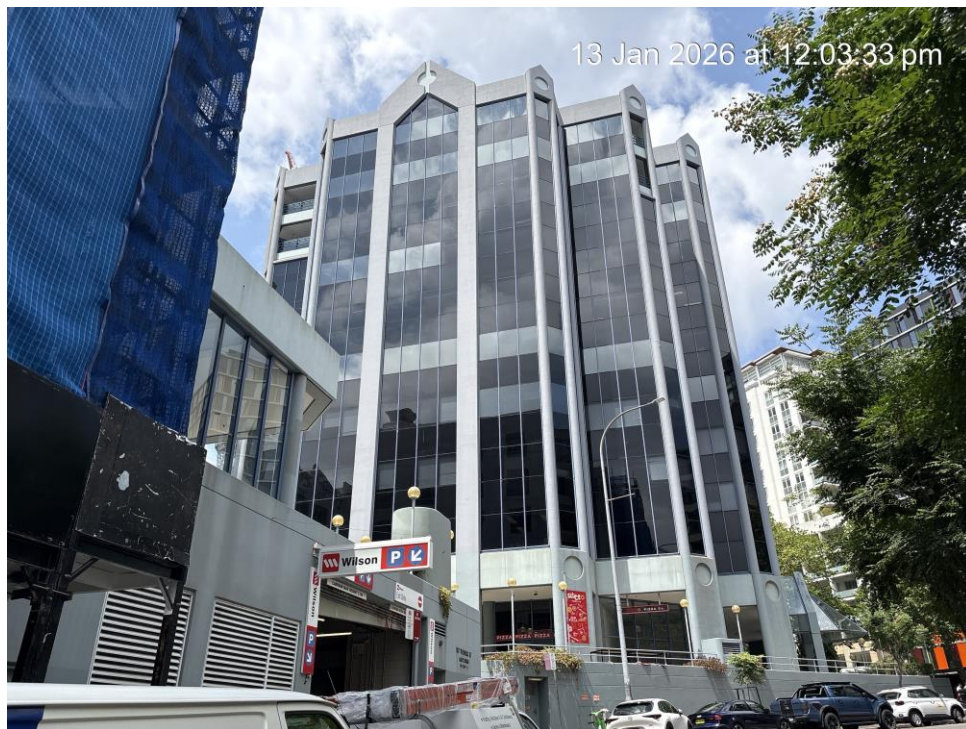
**Figure 1:** 187-189 Thomas Street, Haymarket viewed from the north-west
