## **Report on Footing Investigation**

**Park Royal Hotel Redevelopment**

**150 Day Street, Sydney, NSW**

**Project 231572.00**

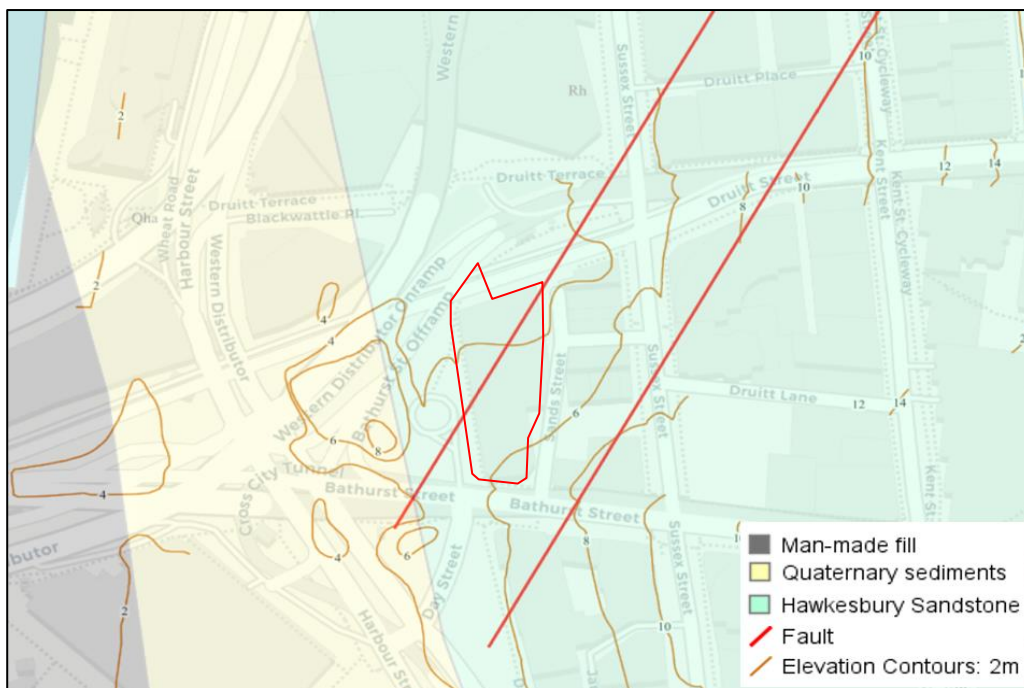
**Figure 1: Subject site geology detailing GPO fault zone**

Reference to Sydney CBD fault zones map (Pells, Braybrooke & Och, 2004), indicates that the site is located within the G.P.O Fault zone. The fault zone extends from the north-east of the subject site to the south-west. Weaker rock and a higher degree of fracturing within the rock mass is expected in the fault zone. An extract from the geological map overlain by 2 m (AHD) contours is shown in Figure 1.
