# Existing Building Services Condition Report

**230655 PARK ROYAL HOTEL  
REDEVELOPMENT**

**Client:**  
UOL

**Date:**  
24/03/2025

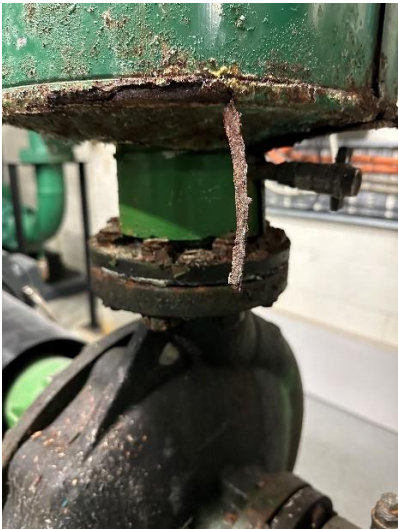
| Infrastructure | Image and General Condition | Re-use Considerations |
|---|---|---|
| <b>Chilled water pipework</b> | <p>Fair to Poor</p> | <ul style="list-style-type: none"> <li>- Must re-evaluate pipe sizing based on updated heat loads in detailed design</li> <li>- Pipe conditions and extent of corrosion cannot be determined from visual inspection and will require ultrasonic non-intrusive testing for re-use evaluation.</li> <li>- Insulation provided required to be updated to latest NCC</li> <li>- Pressure class to be evaluated. Depending on final plant arrangement, can be sufficient.</li> </ul> |

| Asset | Service | Recommendations |
|---|---|---|
| <b>Chilled Water Pipework</b> | Mechanical | Conduct pipe ultrasonic scans of existing chilled water pipework for new hotel rooms to determine suitability of re-use.<br>Maintain or replace according to findings of testing.<br>Bolster insulation accordingly to meet latest NCC standards<br>Replace main chilled water pipework to meet new increased demand and to suit new architectural scheme. |

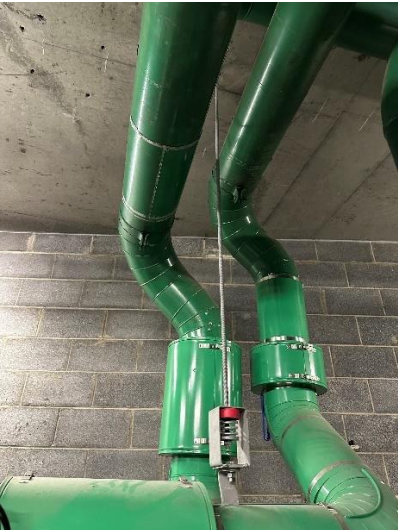
| Infrastructure | Image and General Condition | Re-use Considerations |
|---|---|---|
| <b>Condenser water pipework</b> | <p>Good to Fair</p> | <ul style="list-style-type: none"> <li>- Must re-evaluate pipe sizing based on updated heat loads in detailed design</li> <li>- Pressure class to be evaluated. Depending on final plant arrangement, can be sufficient.</li> <li>- Pipe conditions and extent of corrosion cannot be determined from visual inspection and will require ultrasonic non-intrusive testing for re-use evaluation</li> </ul> |

| Asset | Service | Recommendations |
|---|---|---|
| <b>Condenser Water Pipework</b> | Mechanical | Conduct pipe ultrasonic scans of existing condenser water pipework to determine suitability of re-use.<br>Maintain or replace according to findings of testing.<br>Replace main condenser water pipework to meet new increased demand and to suit new architectural scheme. |

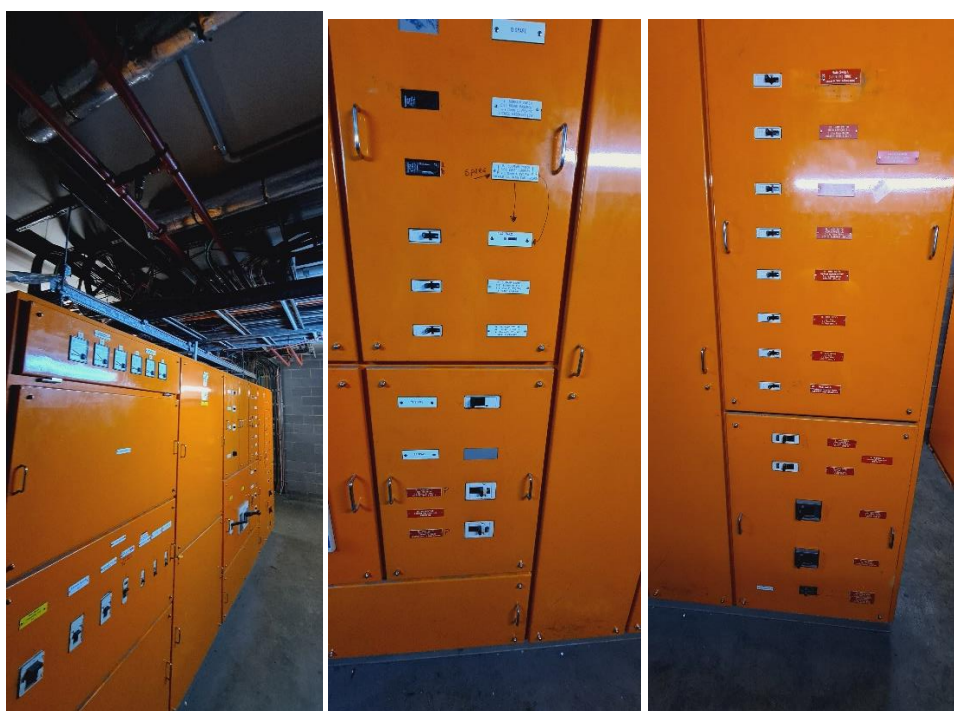
Figure 4-1 : Main Switchboard

The main electrical services Main Switch Room (MSR) is located in the upper basement and serves as the central point of electrical services distribution for the entire building. The switchboard is approaching end of life with no service protection device (SPD) and is not compliant to the current standards(AS 61439). The consumer mains currently originate from Ausgrid substation S.7983(Sussex Sand) and currently has half sized neutral which is also non-compliant to current AS/NZS 3000 requirements.

| Asset | Service | Recommendations |
|---|---|---|
| <b>Main Switchboard</b> | Electrical | Replace to meet latest NCC Standards and to meet new increased demand |

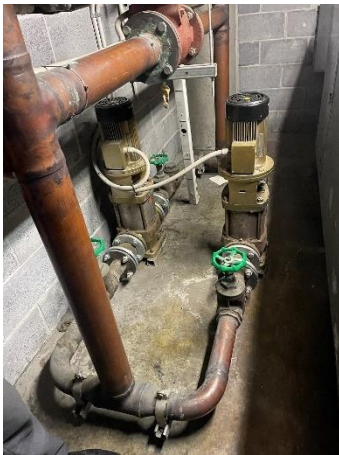
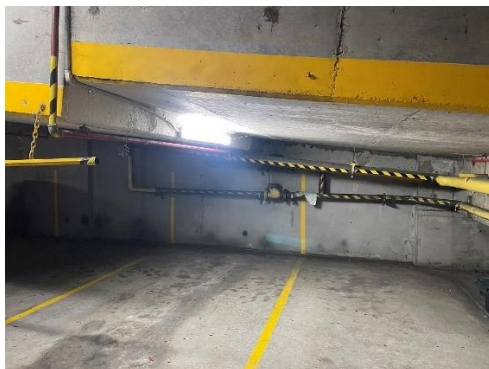
The current potable water services pipework appears to be in poor condition and is sized to cater for the current building scheme. New potable water services pipework should be provided that is adequately sized to cater for the new building scheme,

*Existing CW. transfer pumps.*

*Existing CW. booster pumps.*

*Existing incoming CW. service.*

*Existing Combined CW. & FH water storage tank.*

| Asset | Service | Recommendations |
|---|---|---|
| <b>Potable Water Pipework</b> | Hydraulics | Replace to meet latest NCC Standards and to meet new increased demand |

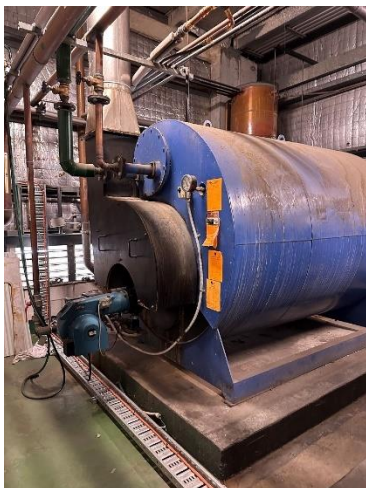
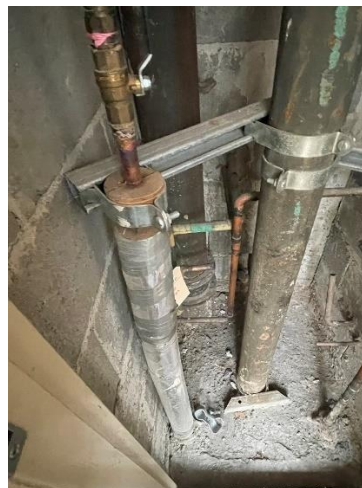
Currently no hot water temperature control devices in the form of tempering valves or thermostatic mixing valves are being utilised on the hot water system as required by the AS3500. New temperature control devices will be provided throughout the building to provide:

*Existing Domestoc HW boiler.*

*Existing Hot Water services pipework.*

| Asset | Service | Recommendations |
|---|---|---|
| <b>Domestic Hot Water Plant</b> | Hydraulics | Replace with heat pumps to meet latest NCC Standards and to meet new increased demand |
| <b>Hot Water Pipework</b> | Hydraulics | Replace to meet latest NCC Standards and to meet new increased demand |

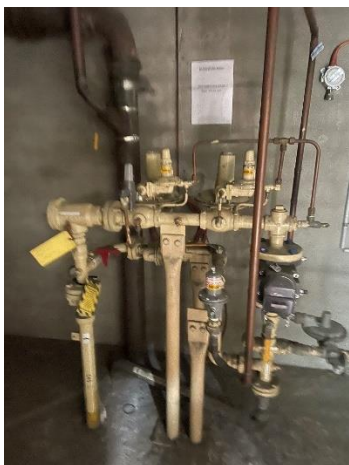
The existing natural gas services reticulates within the building at 100kpa, without being located within a ventilated fire rated shaft in accordance with AS5601. A new boundary regulator will be provided to limit the natural gas supply operating pressure to 7kpa once entering into the building. The building's existing natural gas pipework will be deemed to small to accommodate anticipated natural gas usage at the new lower pressure and will need to be decommissioned and removed. New natural gas service pipework will be run throughout the building to serve to the existing and new gas appliance, sized to cater for the lower gas pressure.

*Existing High pressure gas boundary regulator.*

*Existing Gas regulator serving Domestic HW. plant.*

| Asset | Service | Recommendations |
|---|---|---|
| <b>Gas Services</b> | Hydraulics | Replace to meet latest NCC Standards, City of Sydney Guidelines and to meet new increased demand |

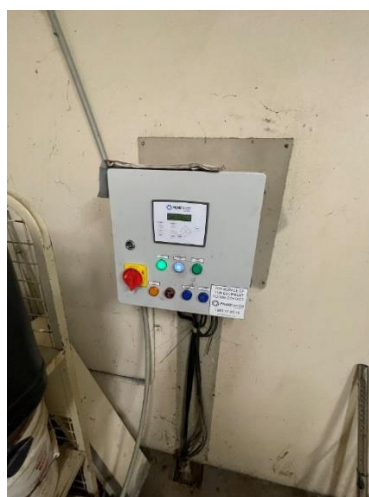
The existing mild steel horizontal stormwater drainage and downpipes appears to be in poor condition and will need to be replaced with new uPVC drainage pipework of adequate size.

The condition of the existing sewer holding well and associated pumps located on Lower ground Basement is expected to need replacing due to being at it's end of life period. A new stormwater holding well and associated pumps will be provided.

Existing L11 roof stormwater outlet and overflow.

Existing Stormwater pumpstation control panel.

| Asset | Service | Recommendations |
|---|---|---|
| <b>Stormwater drainage and downpipes</b> | Hydraulics | Replace to meet latest NCC Standards and to meet new increased demand |
| <b>Stormwater Holding Well</b> | Hydraulics | Replace to meet latest NCC Standards and to meet new increased demand |

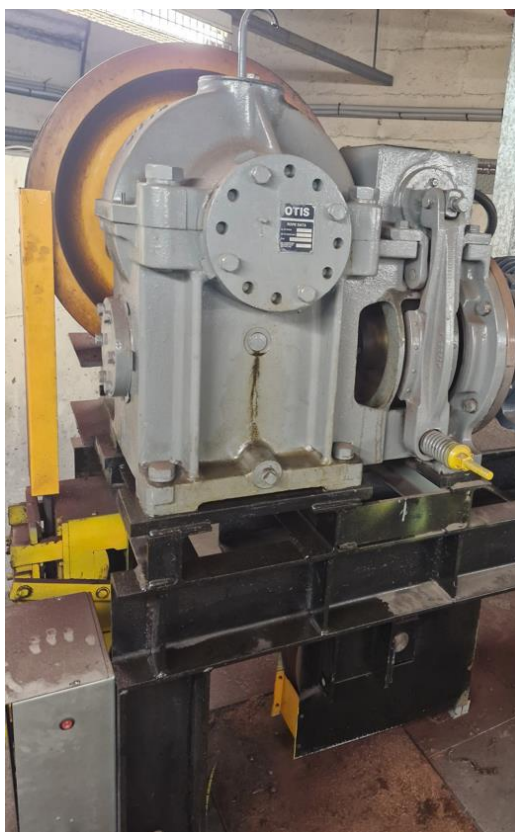
The design life for the modernised components of these lifts is in the order of 15 years for the controllers, drives, lift car and landing control buttons and signalisation, and in the order of 20 years for the car door operator and landing door system. The original Otis Elevator as installed geared machine has reasonably cycled beyond it's operational design life of approx. 25 - 30 years with continuous operation for a period of 33 years.

*Original as-installed Otis Elevator Geared Machine*

Complete replacement of these lifts with larger lift cars (minimum 21 passenger 1600 Kg rated load) can be reasonably considered and is recommended during the proposed extension works.
