# **Attachment D**

**Inspection report  
1-5 Link Road and 132-136 Epsom Road,  
Zetland**

## **Council Investigation Officer Inspection and Recommendation Report; Clause 17(2) Part 8 of Schedule 5 of the Environmental Planning and Assessment Act 1979 (the Act)**

**Premises:** 1-5 Link Road and 132-136 Epsom Road, Zetland

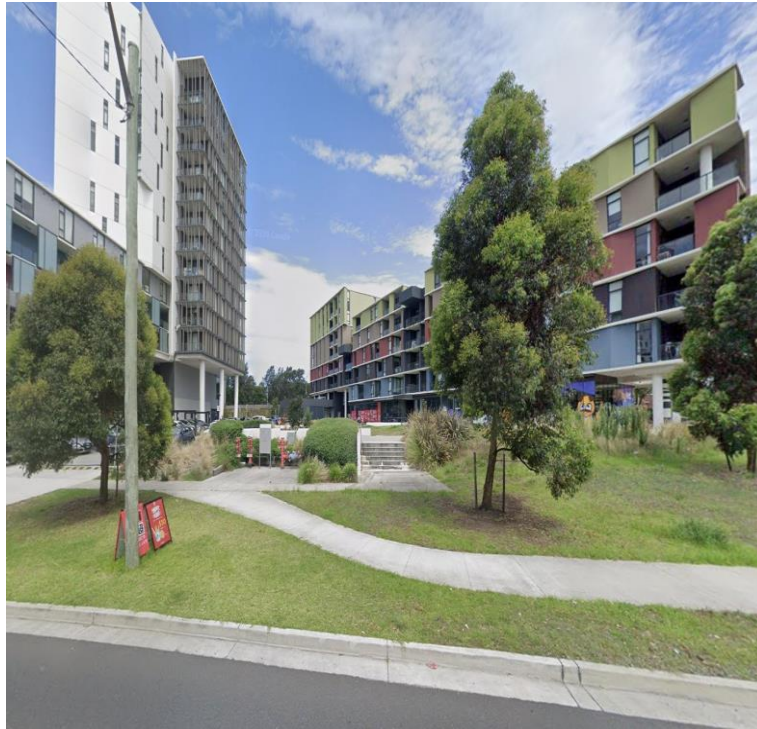
**Figure 1:** 1-5 Link Road and 132-136 Epsom Road, Zetland, viewed from the west
