# **Attachment G**

**Inspection report  
332-338 Riley Street, Surry Hills**

**Council Investigation Officer Inspection and Recommendation Report; Clause 17(2) Part 8 of Schedule 5 of the Environmental Planning and Assessment Act 1979 (the Act)**

**Premises:** 332-338 Riley Street, Surry Hills

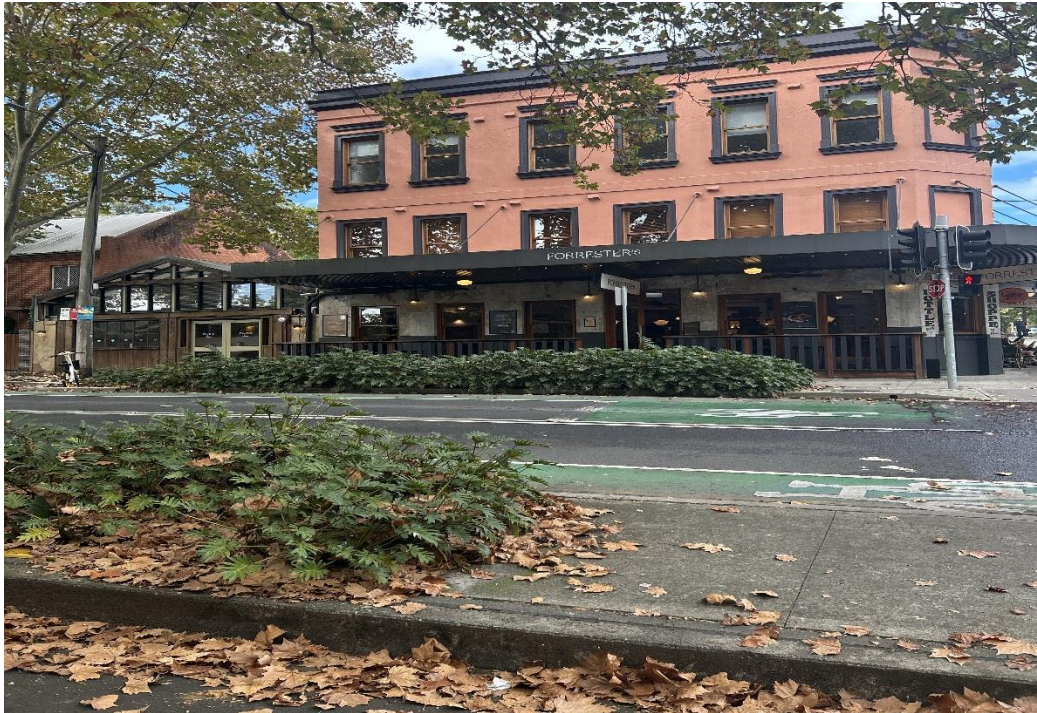
**Figure 1:** 332-338 Riley Street, Surry Hills, viewed from the west
