# **Attachment H**

**Inspection report  
27-39 Abercrombie Street, Chippendale**

## **Council Investigation Officer Inspection and Recommendation Report; Clause 17(2) Part 8 of Schedule 5 of the Environmental Planning and Assessment Act 1979 (the Act)**

**Premises:** 27-39 Abercrombie Street, Chippendale

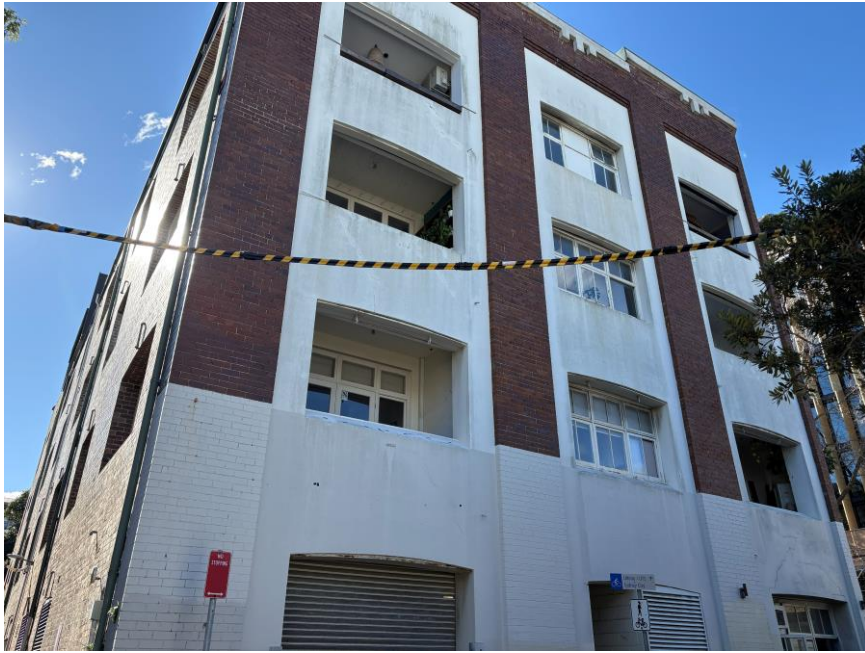
**Figure 1:** 27-39 Abercrombie Street, Chippendale viewed from the north-west
