# **Attachment I**

**Inspection report  
318 Elizabeth Street, Surry Hills**

## **Council Investigation Officer Inspection and Recommendation Report; Clause 17(2) Part 8 of Schedule 5 of the Environmental Planning and Assessment Act 1979 (the Act)**

**Premises:** 318 Elizabeth Street, Surry Hills

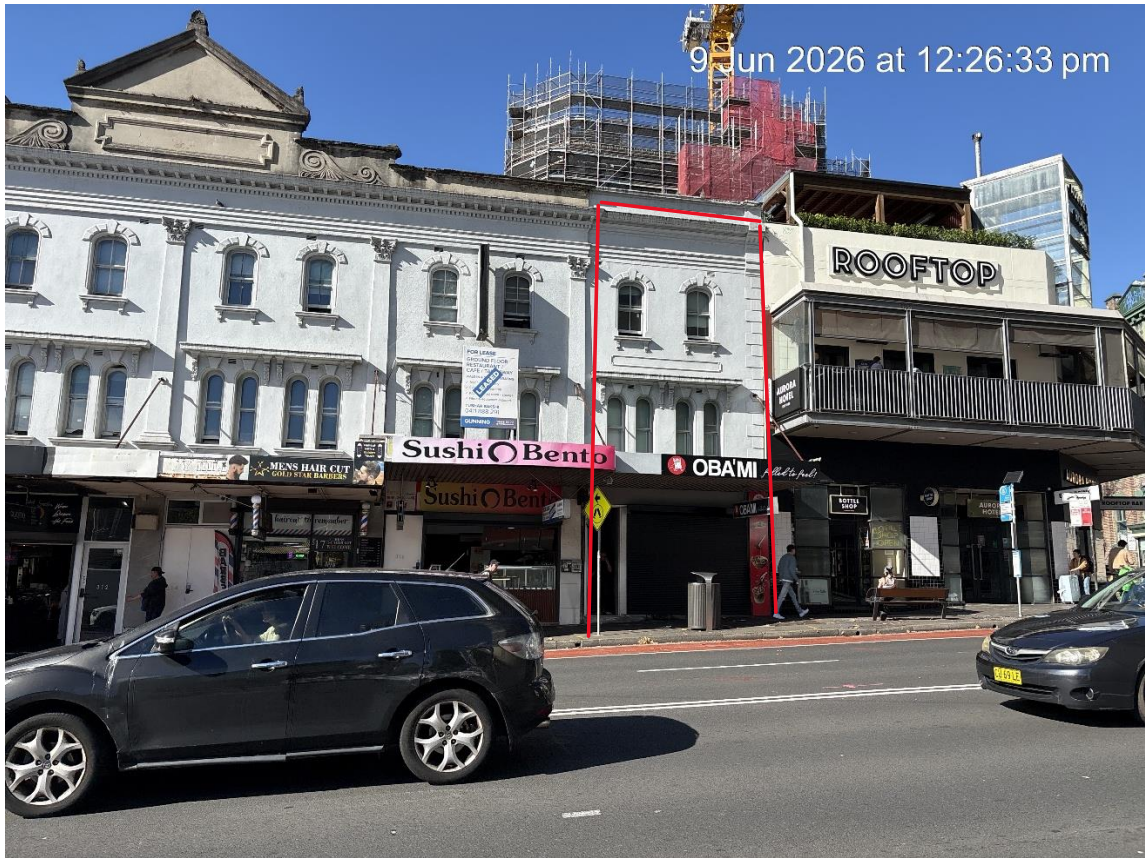
**Figure 1:** 318 Elizabeth Street, Surry Hills viewed from the north-west
