# **Attachment D**

**Inspection Report  
653-659 George Street, Haymarket**

# **Council Investigation Officer Inspection and Recommendation Report; Clause 17(2) Part 8 of Schedule 5 of the Environmental Planning and Assessment Act 1979 (the Act)**

**Premises:** 653-659 George Street, Haymarket

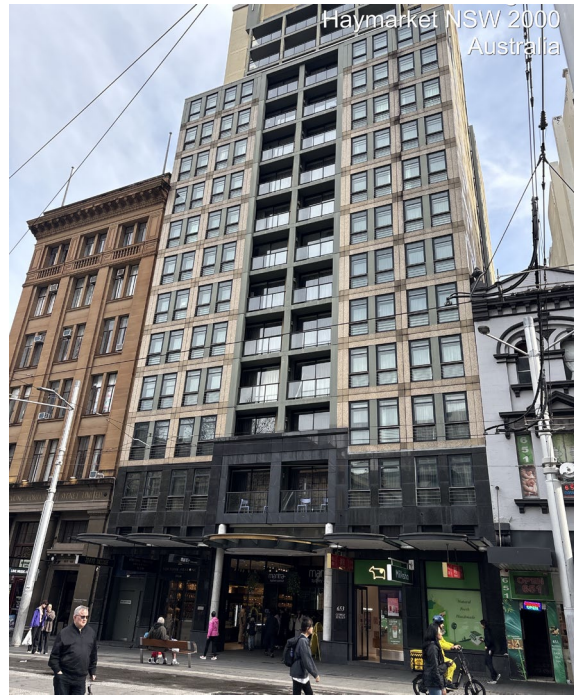
**Figure 1:** 653-659 George Street, Haymarket viewed from the north-west
