| <p><b>Inspection Report</b><br/><b>2-4 Cunningham Street, Haymarket</b></p> |

## 2 - 4 Cunningham Street, Haymarket

**City Investigation Officer Inspection and Recommendation Report**  
**Clause 17(2), Part 8 of Schedule 5, of the Environmental Planning and Assessment**  
**Act 1979 (the Act)**

**Re: INSPECTION REPORT  
ASPECT  
2-4 CUNNINGHAM STREET HAYMARKET ("the premises")**

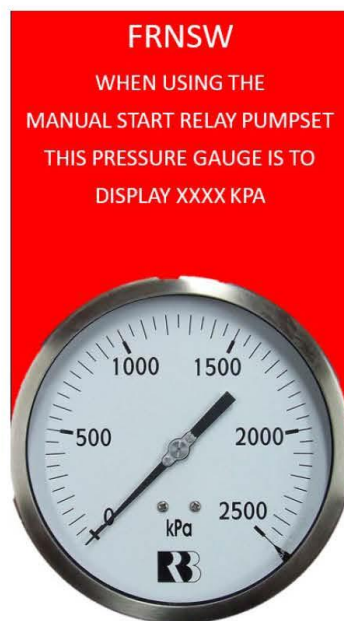
*Figure 1*

FRNSW position statement '[FRNSW pump performance for high rise buildings](#)' states, the fire hydrant system is to be designed for a 'Boost Pressure' of 950 kPa being input into the fire brigade booster connection from a standard FRNSW pumper, for buildings having an effective height greater than 50 m and requiring a fire brigade relay pump. FRNSW are of the opinion that the boost pressure signage should state, BOOST PRESSURE 950kPa and the relay pump be modified to ensure correct operational pressures.

Additional signage should be installed along with a 150mm pressure gauge similar to *Figure 1*, to advise firefighters of the required pressure at the RELAY PUMP discharge.
