# **Attachment B**

**Inspection Report  
8 Central Park Avenue, Chippendale**

**Council Investigation Officer Inspection and Recommendation Report; Clause 17(2) Part 8 of Schedule 5 of the Environmental Planning and Assessment Act 1979 (the Act)**

**Premises:** 8 Central Park Avenue, Chippendale

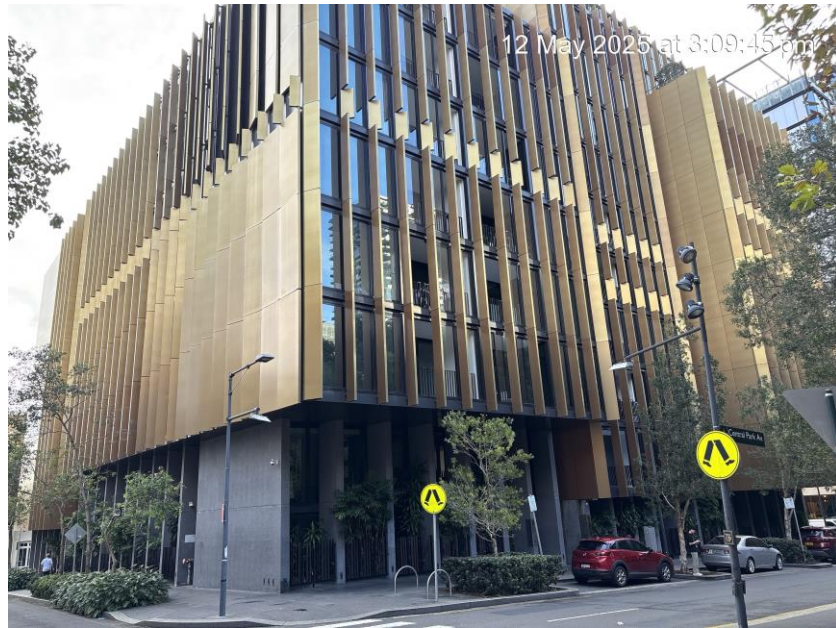
**Figure 1:** 8 Central Park Avenue, Chippendale, viewed from the north-west
