# **Attachment D**

**Inspection Report  
117-119 Kippax Street, Surry Hills**

**Council Investigation Officer Inspection and Recommendation Report; Clause 17(2) Part 8 of Schedule 5 of the Environmental Planning and Assessment Act 1979 (the Act)**

**Premises:** 117-119 Kippax Street, Surry Hills

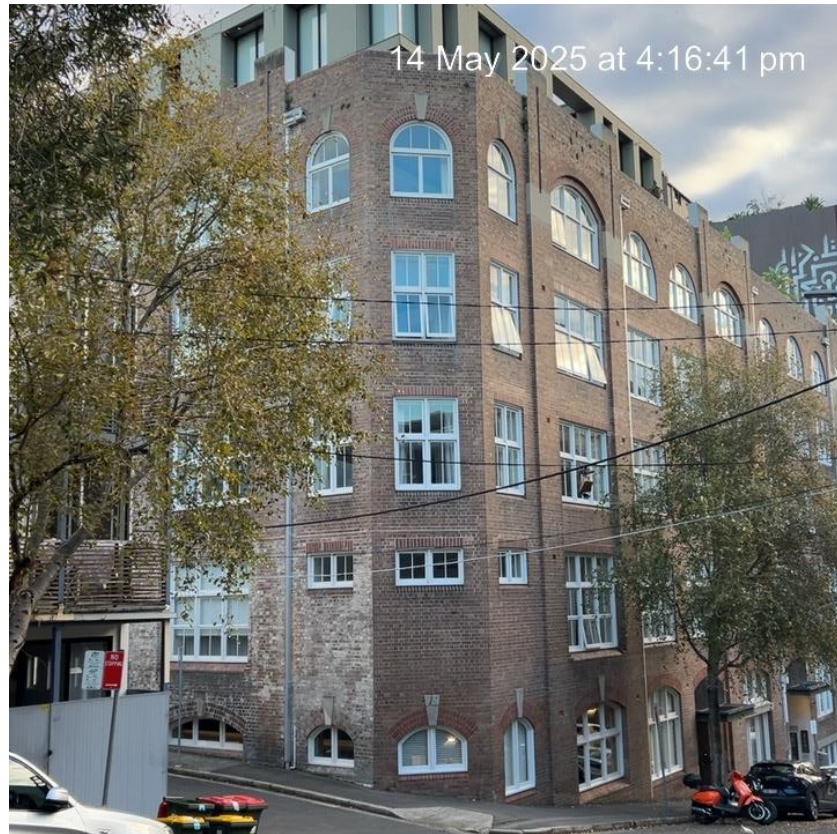
**Figure 1:** 117-119 Kippax Street, Surry Hills, viewed from the south-west
