# **Attachment E**

**Inspection Report  
82-88 Elizabeth Street, Sydney**

## **Council Investigation Officer Inspection and Recommendation Report; Clause 17(2) Part 8 of Schedule 5 of the Environmental Planning and Assessment Act 1979 (the Act)**

**RE: REQUEST FOR COMMENT  
BERGER HOUSE  
82-88 ELIZABETH STREET SYDNEY ("the premises")**

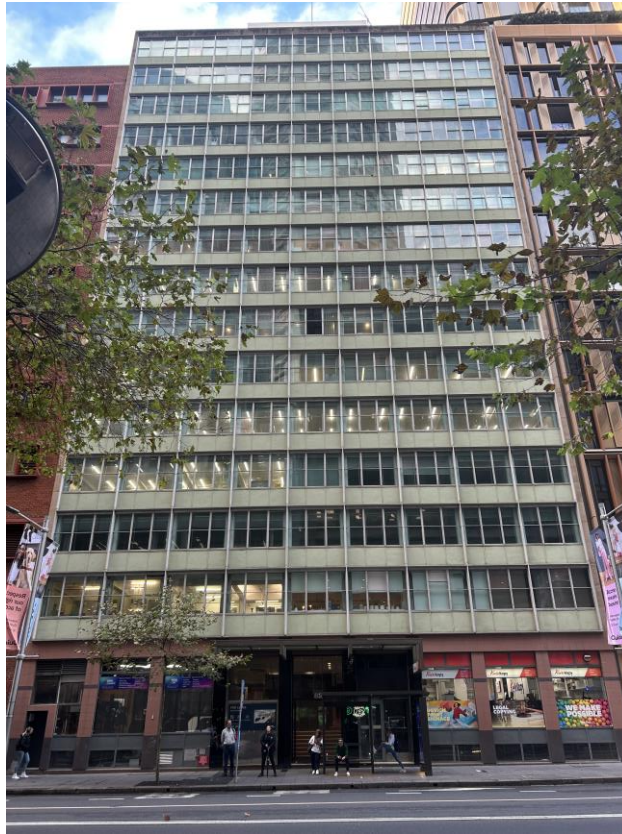
**Figure 1:** 82-88 Elizabeth Street, Sydney, viewed from the east

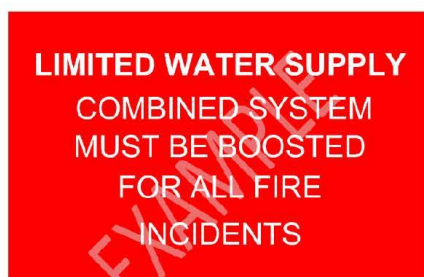
Figure 1

5. The on-site water storage has an exhaustible supply, which will require firefighters to supplement the onsite water storage, by boosting the combined system. Signage at the FDCIE and booster assembly is to be installed for firefighter information. The signage is to state, *LIMITED WATER SUPPLY COMBINED SYSTEM MUST BE BOOSTED FOR ALL FIRE INCIDENTS*. See Figure 1.

1. Signage be installed at the Fire Detection and Control Indicating Equipment (FDCIE) and at the booster assembly, in a colour contrasting that of the

background, a minimum size of A4, stating, *LIMITED WATER SUPPLY. COMBINED SYSTEM MUST BE BOOSTED FOR ALL FIRE INCIDENTS.*

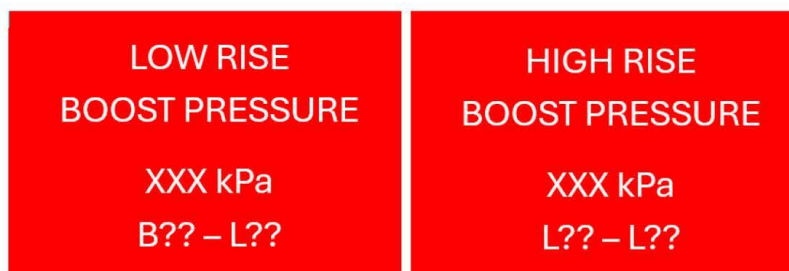
Figure 2

6. The combined booster assembly incorporates two boost inlet connections, for a high and low stage pressure zones. Signage is to be installed at the booster assembly for each boost inlet connection which states, LOW RISE BOOSTER B??- L?? and HIGH RISE BOOSTER L?? – L?? to the requirements of Clause 7.10 of Australian Standard (AS) 2419.1-2005. See Figure 2.

2. Boost pressure signage is to be installed immediately behind each inlet connection in a colour contrasting that of the background, a minimum A4.
3. The installation of controls for the pumps and signage showing the location of the pump room at the FIP in accordance with the Fire Engineering Report.
4. The non-return valves within the stairwells for the mist system be re-configured to ensure the valves close under gravity with no water flow.
