# **Attachment E**

**Inspection Report  
82-88 Elizabeth Street, Sydney**

# **Council Investigation Officer Inspection and Recommendation Report; Clause 17(2) Part 8 of Schedule 5 of the Environmental Planning and Assessment Act 1979 (the Act)**

**RE: REQUEST FOR COMMENT  
BERGER HOUSE  
82-88 ELIZABETH STREET SYDNEY ("the premises")**

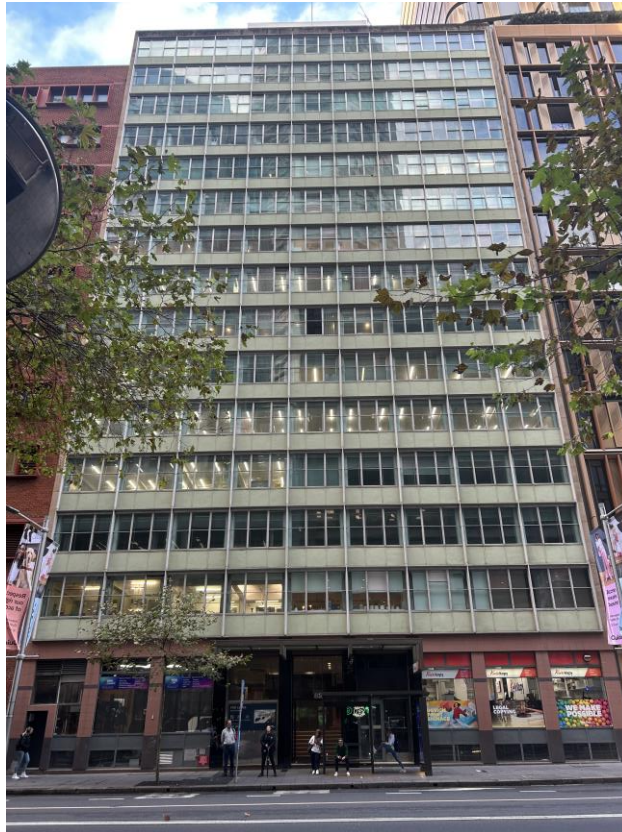
**Figure 1:** 82-88 Elizabeth Street, Sydney, viewed from the east

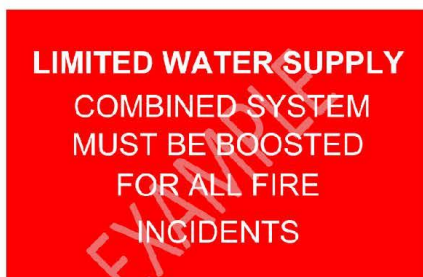
Figure 1

| Ref. | Issue | City response |
|---|---|---|
| 5 | The on-site water storage has an exhaustible supply, which will require firefighters to supplement the onsite water storage, by boosting the combined system. Signage at the FDCIE and booster assembly is to be installed for firefighter information. | FRNSW's advice is noted and may be taken into consideration in any future modification of the City's Fire Safety Order. |

5. The on-site water storage has an exhaustible supply, which will require firefighters to supplement the onsite water storage, by boosting the combined system. Signage at the FDCIE and booster assembly is to be installed for firefighter information. The signage is to state, *LIMITED WATER SUPPLY COMBINED SYSTEM MUST BE BOOSTED FOR ALL FIRE INCIDENTS*. See Figure 1.

1. Signage be installed at the Fire Detection and Control Indicating Equipment (FDCIE) and at the booster assembly, in a colour contrasting that of the

background, a minimum size of A4, stating, *LIMITED WATER SUPPLY. COMBINED SYSTEM MUST BE BOOSTED FOR ALL FIRE INCIDENTS.*

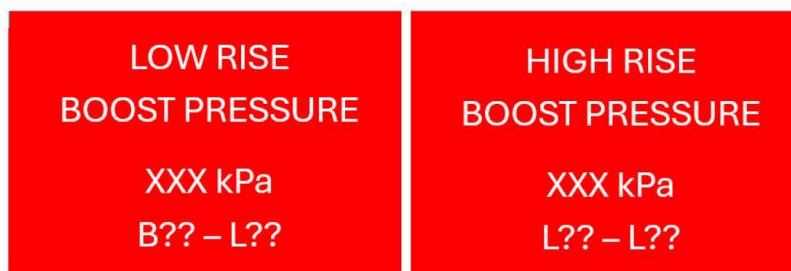
Figure 2

| Ref. | Issue | City response |
|---|---|---|
| 6 | The combined booster assembly incorporates two boost inlet connections, for a high and low stage pressure zones. Signage is to be installed at the booster assembly for each boost inlet connection which states, LOW RISE BOOSTER B?-L?? and HIGH RISE BOOSTER L?? – L?? to the requirements of Clause 7.10 of Australian Standard (AS) 2419.1-2005. | FRNSW's advice is noted and may be taken into consideration in any future modification of the City's Fire Safety Order. |

6. The combined booster assembly incorporates two boost inlet connections, for a high and low stage pressure zones. Signage is to be installed at the booster assembly for each boost inlet connection which states, LOW RISE BOOSTER B??- L?? and HIGH RISE BOOSTER L?? – L?? to the requirements of Clause 7.10 of Australian Standard (AS) 2419.1-2005. See Figure 2.

2. Boost pressure signage is to be installed immediately behind each inlet connection in a colour contrasting that of the background, a minimum A4.
3. The installation of controls for the pumps and signage showing the location of the pump room at the FIP in accordance with the Fire Engineering Report.
4. The non-return valves within the stairwells for the mist system be re-configured to ensure the valves close under gravity with no water flow.
