# **Attachment D**

**Inspection Report  
107-109 Darlinghurst Road, Potts Point**

**Council Investigation Officer Inspection and Recommendation Report; Clause 17(2) Part 8 of Schedule 5 of the Environmental Planning and Assessment Act 1979 (the Act)**

**Re: INSPECTION REPORT  
URBAN NOMADS  
107-109 DARLINGHURST ROAD POTTS POINT ("the premises")**

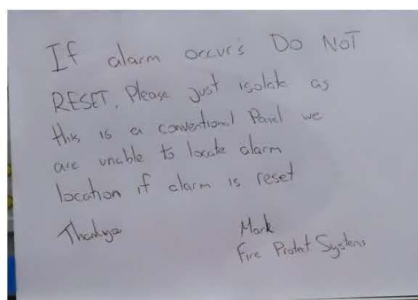
4. The Building Occupant Warning System (BOWS) did not provide sound through all occupied areas contrary to the requirements of Specification S20C7 of the National Construction Code 2022, Volume 1 Building Code of Australia (NCC). The roof top area did not contain any speakers for the BOWS.
5. The smoke detectors within the communal kitchen on level 3 were covered by rubber gloves contrary to the requirements of AS 1670.1–2018.
6. The Fire Indicator Panel included a handwritten note from Mark from Fire Protect Systems (see below). FRNSW do not recommend the isolation of detectors that are able to be reset. Isolation of detectors renders that detector inoperable and will not operate the BOWS to warn occupants in the case of fire.
