**Inspection Report  
180 Pitt Street, Waterloo**

# **Council Investigation Officer Inspection and Recommendation Report; Clause 17(2) Part 8 of Schedule 5 of the Environmental Planning and Assessment Act 1979 (the Act)**

**Premises:** 180 Pitt Street, Waterloo

**Re: INSPECTION REPORT  
'DANIEL SOLANDER'  
180 PITT STREET WATERLOO (hereafter "the premises")**

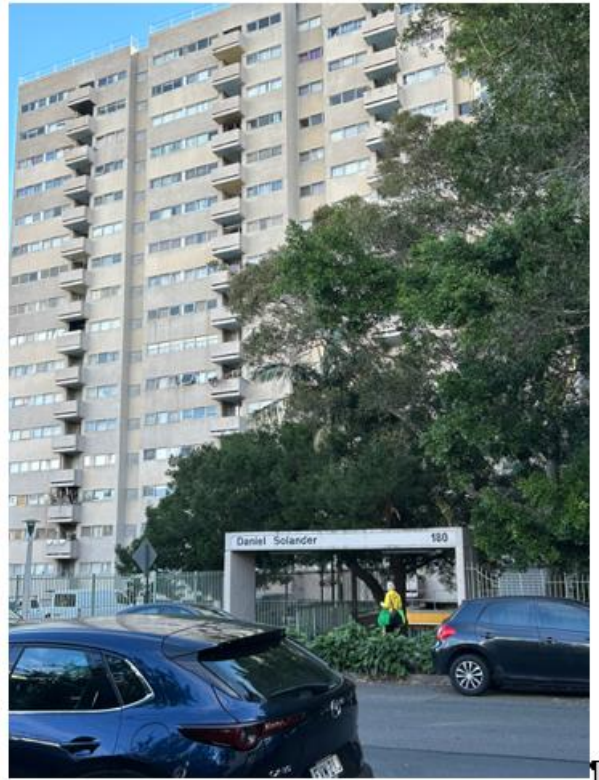
**Figure 1:** 180 Pitt Street, Waterloo, viewed from the north-east
