## **Report on Detailed Site (Contamination) Investigation**

**Proposed Mixed Use Development**

**41-49 Mountain Street, Ultimo NSW**

**Project 231957.01**

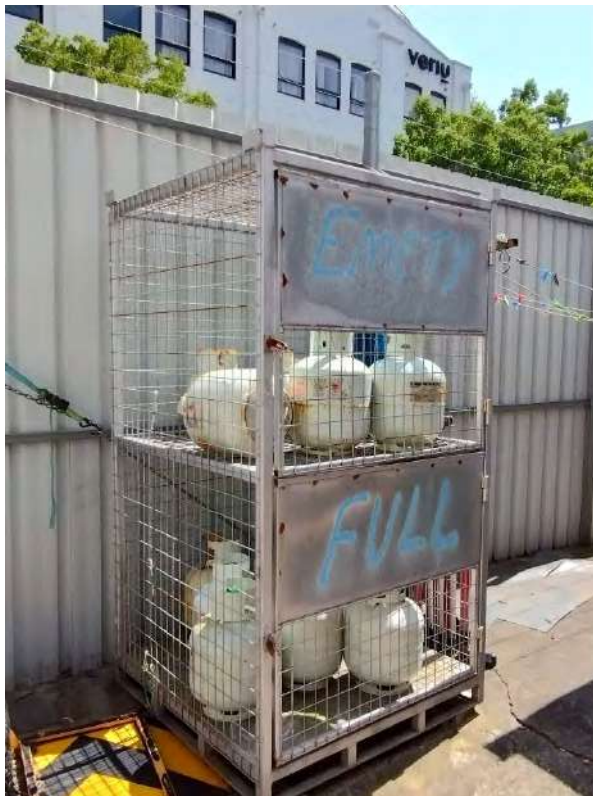
- Vehicle batteries and a small fuel container were observed at the ground surface to the east of a demountable (Photograph 3);
- Petroleum gases liquid cylinders were stored in metal cage located in the north-east of the site, to the west of the substation (Photograph 4);

Photo 4: Gas cylinders located in the north-east part of the site
