Report on  
Acid Sulfate Soils Desktop Study Review and  
Preliminary ASS Management Plan

Proposed Commercial Development  
383 Kent Street, Sydney

Prepared for  
Charter Hall Holdings Pty Ltd

Project 217267.02  
December 2023

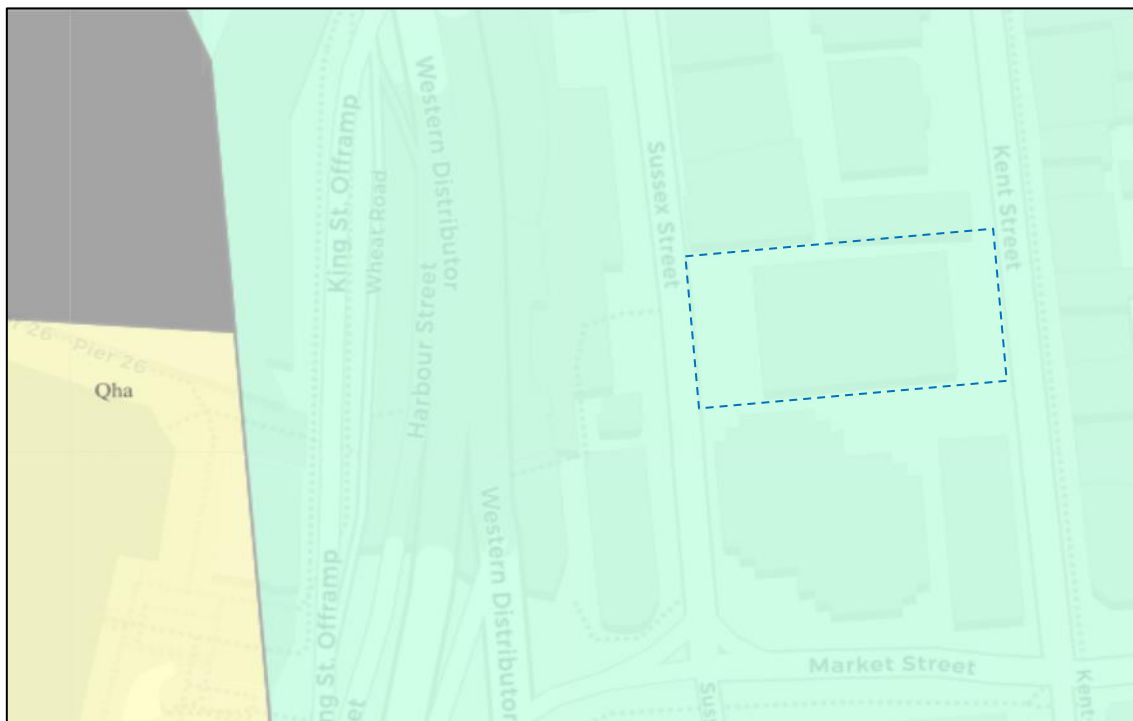
**Figure 1: Extract of Sydney 1:100 000 Geology Sheet (site locality shown as dashed line)**

| Geology | <p>Reference to the Sydney 1:100 000 Geological Series Sheet indicates that the site is underlain by Hawkesbury Sandstone, symbol Rh, of Triassic age, which typically comprises medium to coarse-grained quartz sandstone with minor shale and laminite lenses. This geological unit is not considered 'geologically recent'.</p> <p>It is noted that beyond the western edge of the site boundary, there are Quaternary sediments, symbol Qha, which contain silty to peaty quartz sand, silt and clay. An extract of the Sydney 1:100 000 Geology Sheet is shown below in Figure 1. The site locality is indicated in a dashed, blue outline in Figure 1.</p> |

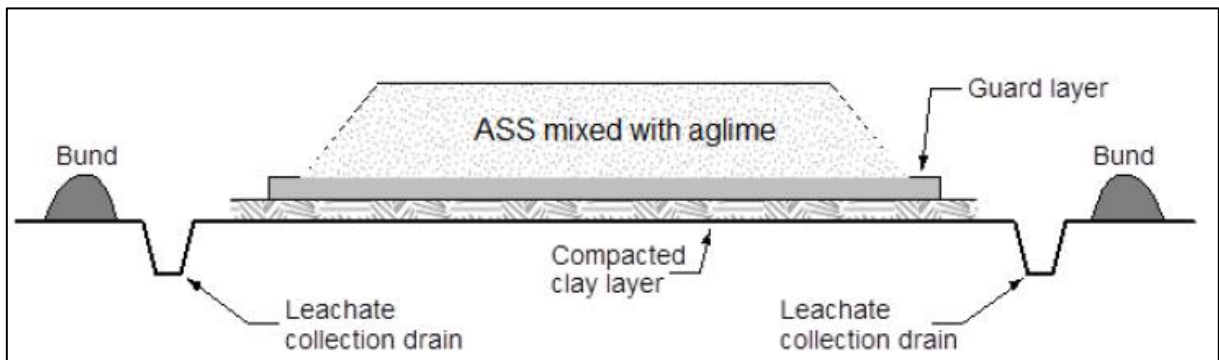
**Figure 4: Schematic cross-section of a treatment pad**

- o The guard layer should be re-applied following removal of treated soils prior to addition of untreated ASS; and
  - o NOTE: if the stockpiled soils on the treatment pad are expected to be greater than 3.0 m in height, it is recommended that the guard layer be applied as a base guard layer, with interim guard layers through the height of the stockpile.

- **Bunding** - The treatment pad should be bunded to contain and collect potential leachate runoff within the treatment pad area and to prevent surface water from entering the treatment pad. The inner bund slopes should be lined to prevent leachate seeping into the ground surface and sized such as to prevent overflow of untreated leachate onto the site.
