Report on  
Acid Sulfate Soils Desktop Study Review and  
Preliminary ASS Management Plan

Proposed Commercial Development  
383 Kent Street, Sydney

Prepared for  
Charter Hall Holdings Pty Ltd

Project 217267.02  
December 2023

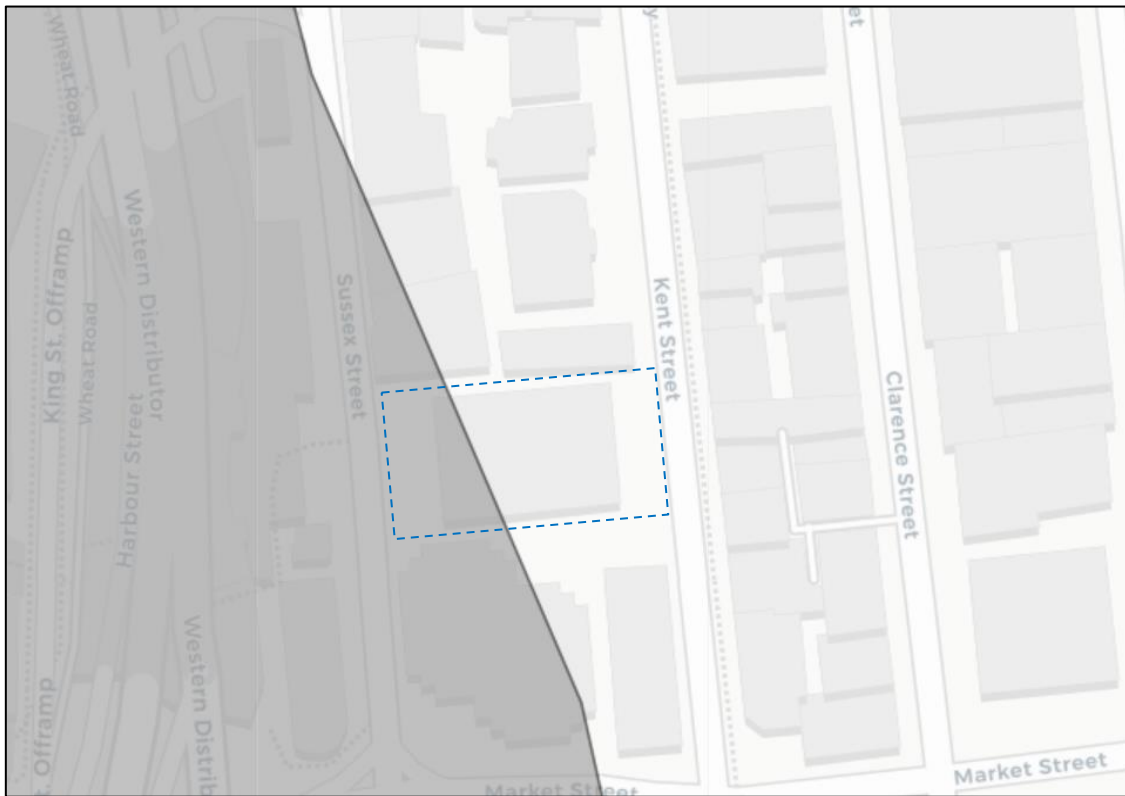
**Figure 3: Extract of NSW Acid Sulfate Soil Risk Map 1998 (site locality shown as dashed line)**

The NSW Department of Environment and Climate Change 1:25 000 ASS risk map (1998) is shown in Figure 3. The site locality is indicated in a blue dashed outline. Figure 3 shows that the western portion of is mapped as disturbed terrain, indicating that a soil investigation is needed to establish whether ASS exists at the site or not.

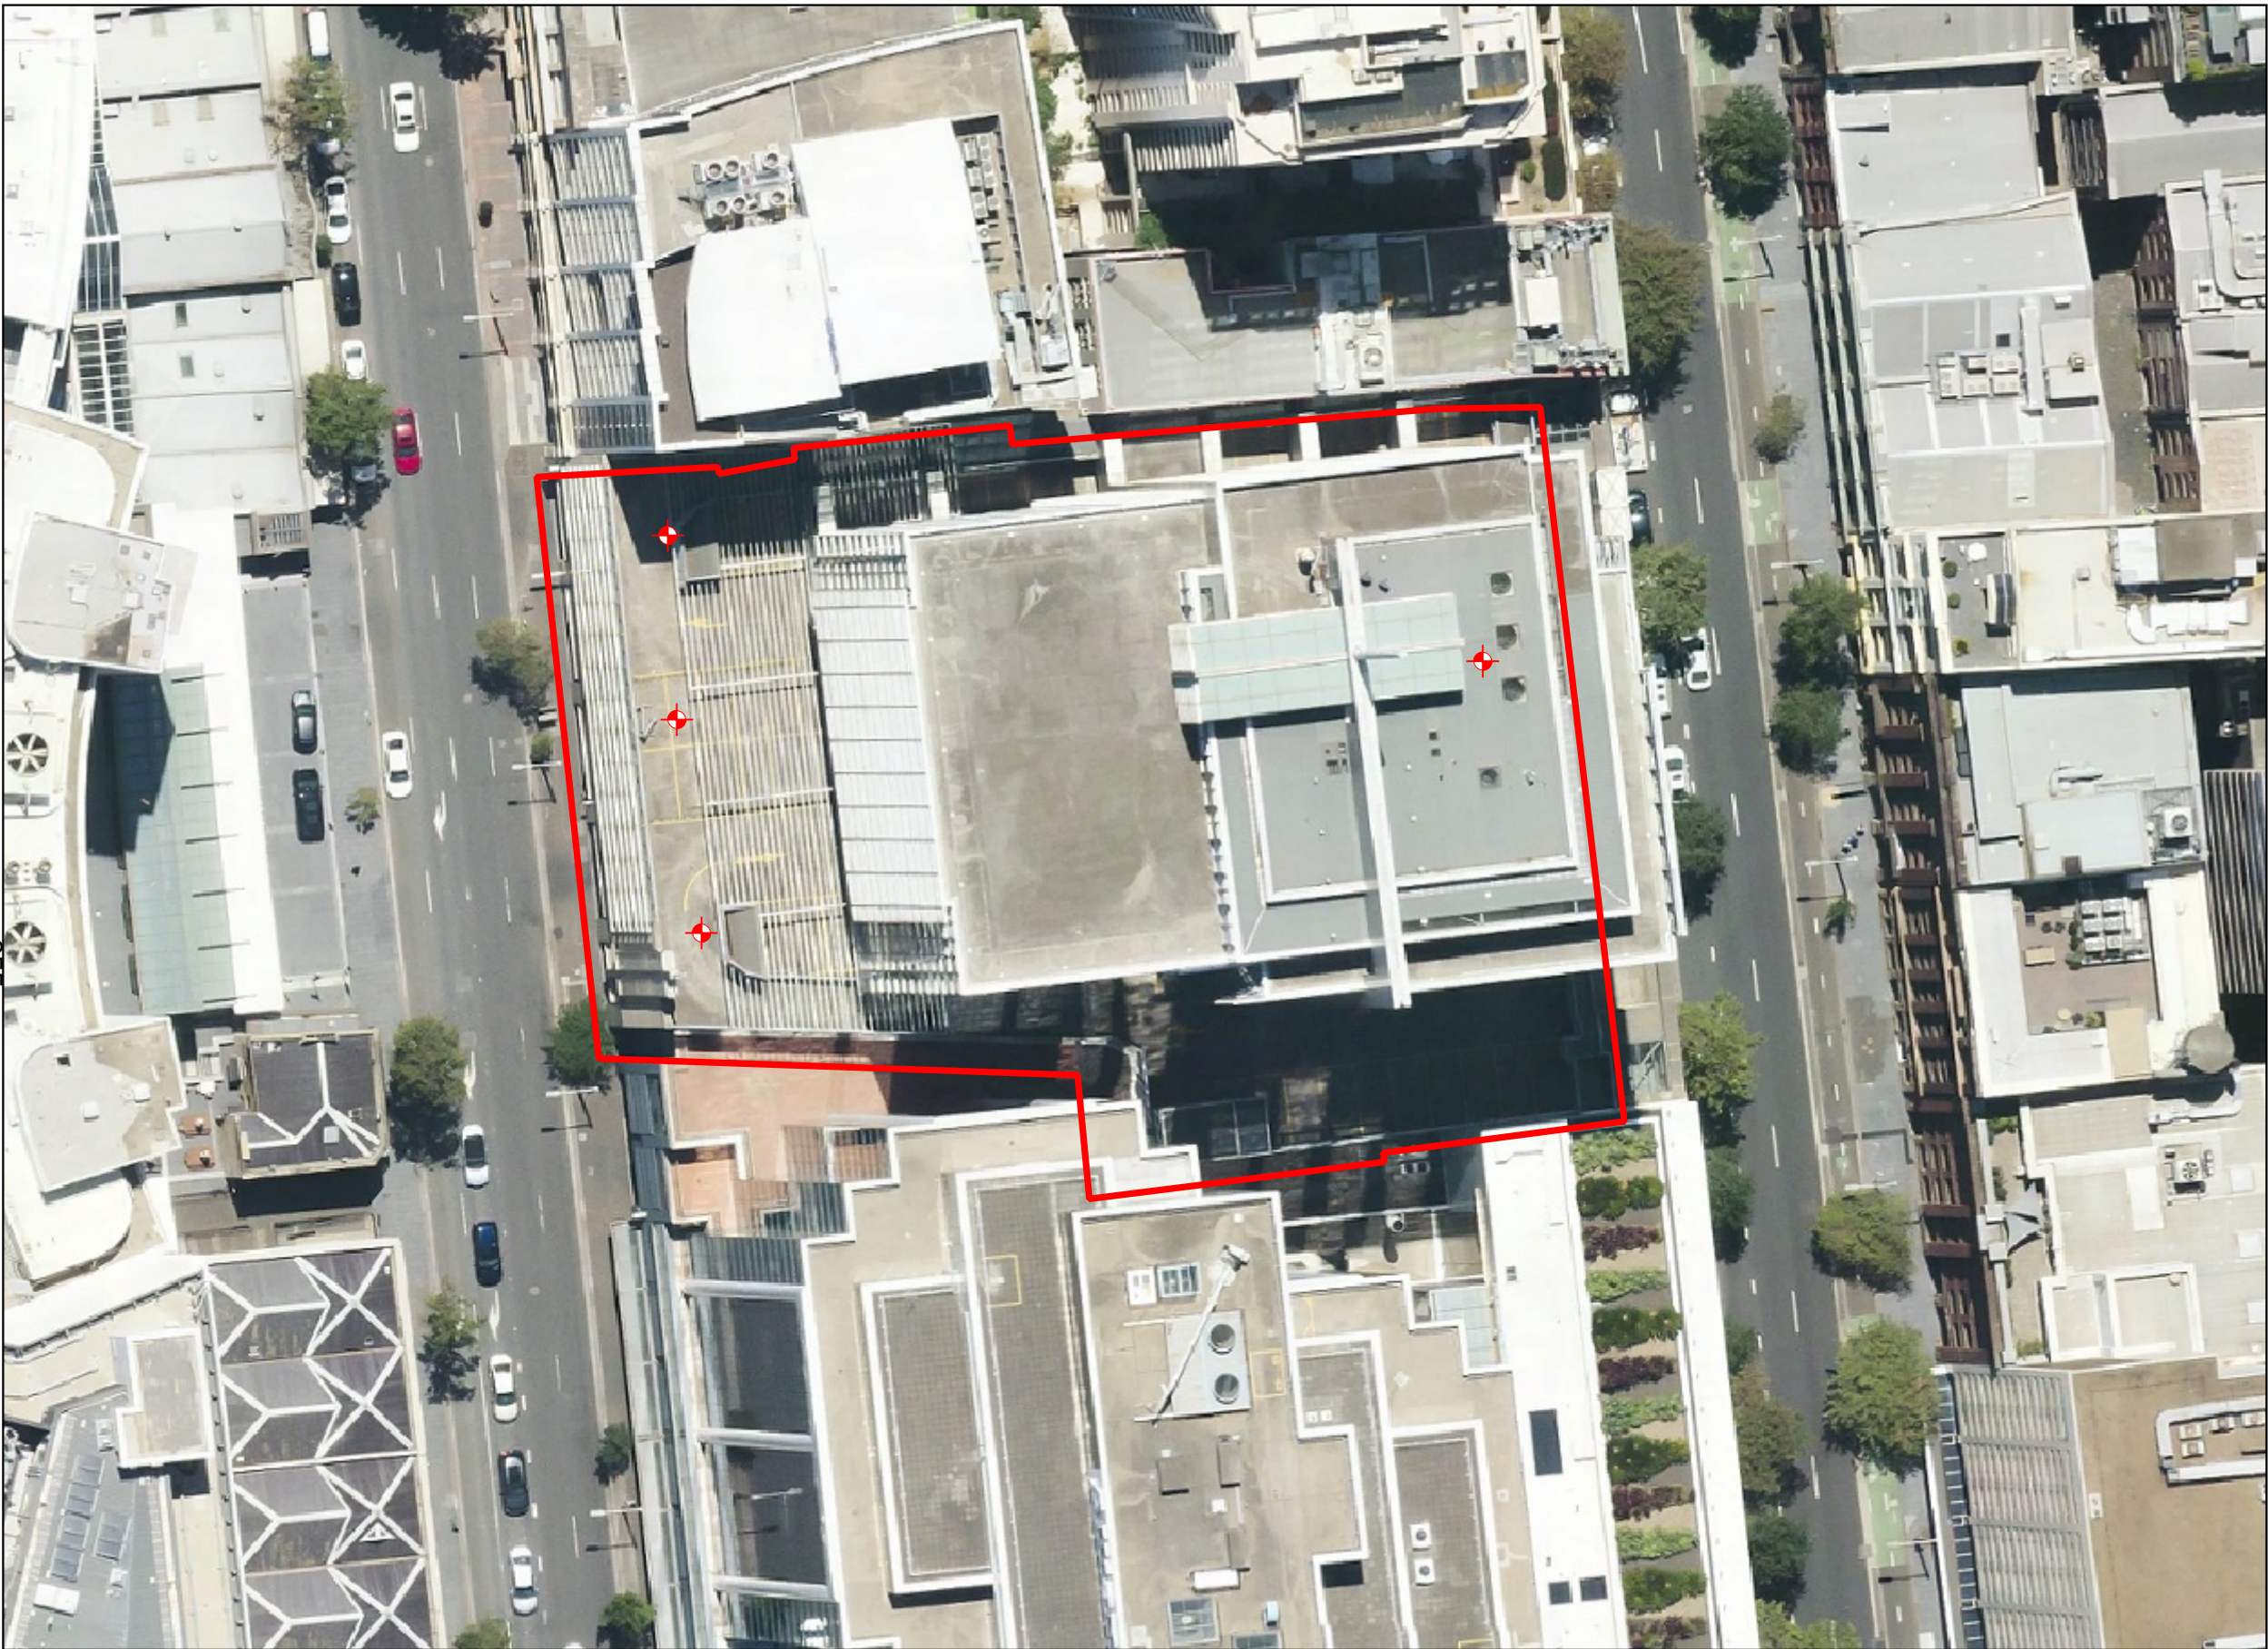
Site Location

| Site Address | 383 Kent Street, Sydney, refer to Drawing 1, Appendix B |
