# Swept Paths - Ref 665 – 145 Missenden Road, Camperdown

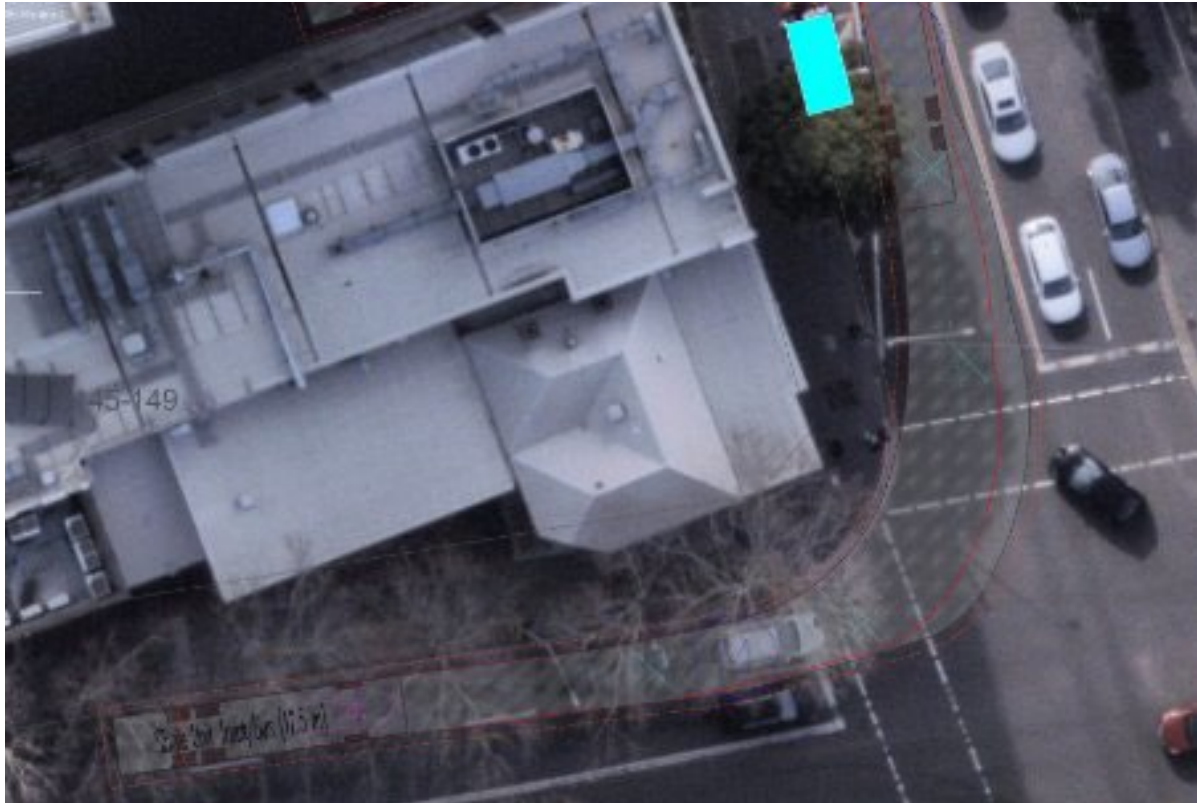
Swept paths under existing conditions show 12.5m bus turning left in kerbside lane from Carillon Avenue to Missenden Road has tail swing into centre lane.

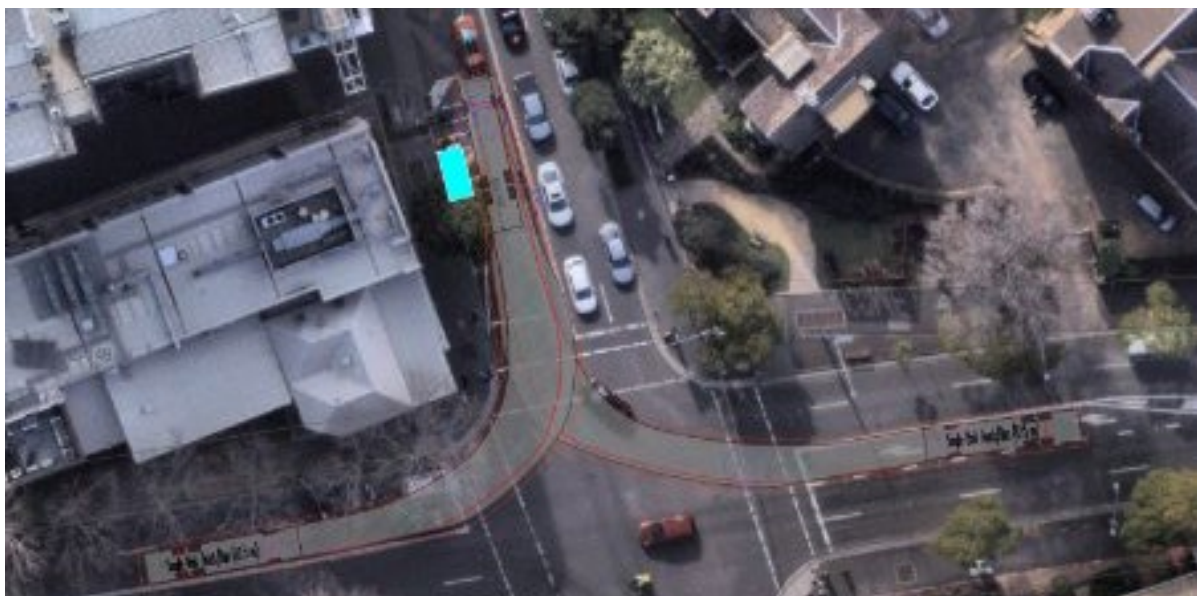
Swept paths under proposed conditions show 12.5m bus needs to turn left from centre lane of Carillon Avenue to Missenden Road. Feedback is requested from bus operators on this proposal and regarding how bus drivers typically approach this turn under existing conditions.
